## Teknos Technical Library

On-Site Guide

# RESIN & KNOT STAINING ON-SITE RECTIFICATION

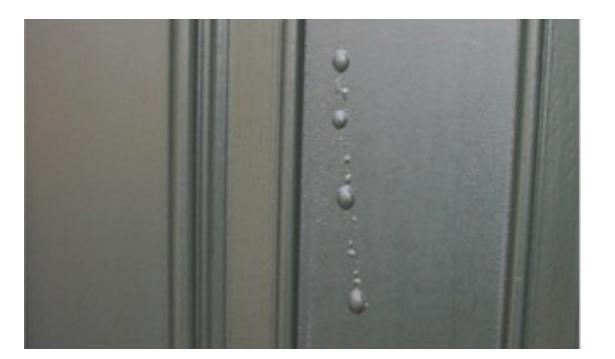
With resinous timber, exhudation is most likely to occur on south facing elevations and on dark surfaces when the heat of the sun liquifies and mobilises the resin, drawing or pneumatically driving it to the surface.

Although it may be unsightly, it is better not to remove fresh sticky resin. In practice, this can be very difficult, and the presence of sticky resin indicates that the exudation is still continuing.

When resin has exuded through a permeable coating, the best remedial treatment is to allow the resin to weather until it dries and oxidises, forming a white crystalline powder.

The dried resin can then be removed with a stiff nylon or natural bristle brush, and any remaining residues wiped off with a cloth.

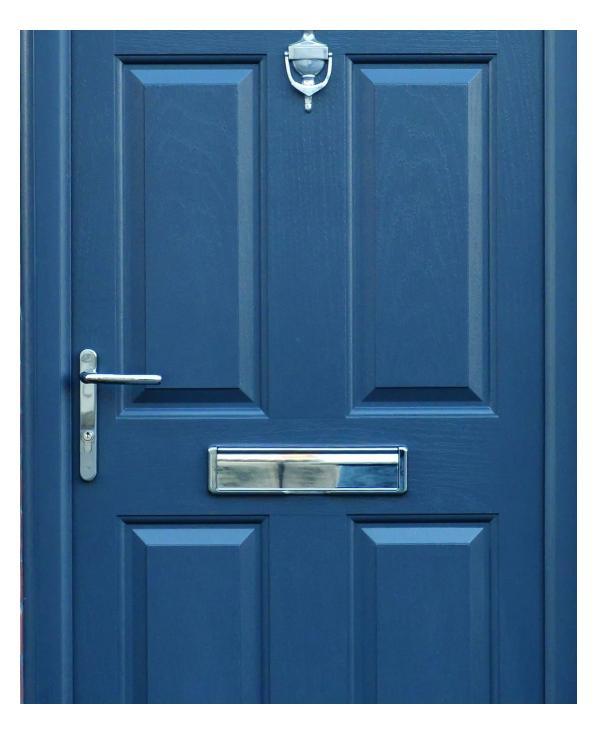
Water based coatings, with their relatively high degree of moisture vapour permeability, are more likely to allow the passage of resin to the surface without damage to the coating. If the finish is not damaged by over-vigorous scrubbing during crystal removal, re-coating is often unnecessary.

The remedial work for resin exudation is often **best left until the first maintenance period**, by which time the resin has normally fully crystallised. After removal as described above, the overall application of one maintenance coat of finish restores the general appearance of the timber and maintains its protection.

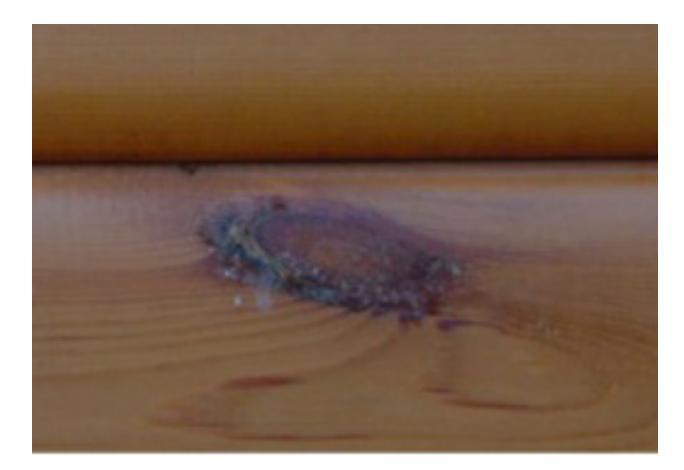
Knot discolouration is caused by the migration of water soluble extractives. Whilst it will not impair the service life of the joinery it can be unsightly.

Tannin migration is influenced by many factors, and it is important to identify the probable cause of staining before starting any remedial work.

If knot staining occurs there are a number of practical ways to restore the decorative finish. The options shown will normally give a satisfactory result if the coating surface is sound and has not been disrupted by physical resin exudation.

- 1. Clean down and wipe the abraded area with a damp microfibre cloth to remove dust, and allow to thoroughly dry.
- 2. Prime with AQUAPRIMER 2900 base stain in the original colour for translucent systems
- 3. Seal any slightly open joints with Teknos V JOINT SEALER. Wipe with a damp cloth or spatula to give a smooth joint and allow to dry. Take further advice for gaps greater than 1mm.
- 4. Seal any exposed end grain with Teknos end grain sealer and allow to thoroughly dry.
- 5. Apply two coats of Teknos translucent topcoat as the final layers.

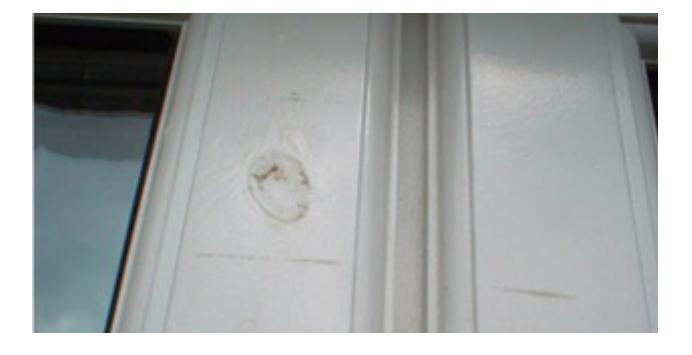
This is a more extensive solution and involves the use of an additional coating to provide a more robust resistance to potential future staining from resinous extractives.

- 1. Lightly abrade the discoloured area with a fine grade abrasive paper.
- 2. Clean down and wash the area to be coated, to remove dirt and allow to dry thoroughly.
- 3. Spot prime all discoloured areas with a primer. Allow to dry thoroughly.
- 4. Fill and level any surface defect using TEKNOFILL 5001 fine surface filler (anything in excess of 1mm deep, should be filled with a suitable 2-pack filler)
- 5. Feather out the repair using a fine grade abrasive paper.
- Using a good quality long haired synthetic brush, designed for use with acrylic paints, apply a single coat of AQUATOP 2600 in the appropriate shade/ colour to the affected component. Allow to dry thoroughly.
