Avoiding winter problems on exterior joinery

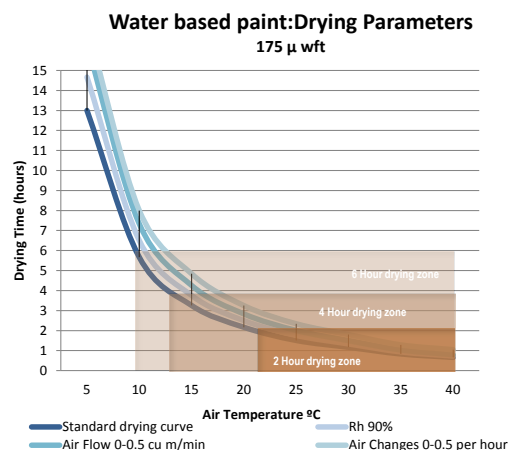
The graph below shows a typical coalescence curve for water based acrylic paint. At lower temperatures, and with poor airflow, coalescence times are significantly extended, so although the paint may feel dry, it will still hold significant moisture.

Achieving a uniform coalesced film is critical to performance. If water is not removed fully, the film will be disrupted, will not cure uniformly and remain susceptible to moisture, blistering and staining.

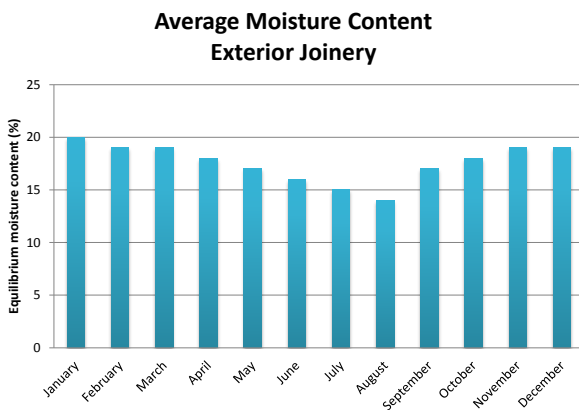
The ambient moisture content of exterior joinery varies significantly through the year and is generally independent of any treatment or finishes applied to it.

Dimensional change is a function of species and grade, but broadly timber dimensions vary by about 1% for every 3% change in moisture content.

In winter, it is not untypical for joinery to leave the factory at around 10% moisture content, sometimes lower if using laminated sections, then rapidly condition to 18-20% on site. The resulting 3 - 4% dimensional changes cause joints and seals to open, letting moisture penetrate unprotected end grain and rebates.
